# CELOS INFORMATION BULLETIN NUMBER 7: INVENTORY: THE CSA PLAYGROUND PROJECT at DUFFERIN GROVE PARK

## A FOLLOW UP OF THE CSA CHANGES MADE AT DUFFERIN GROVE PARK

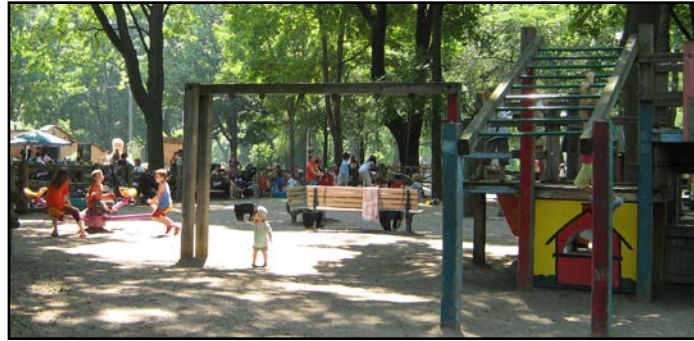
< 1999 inspection: "three baby swings attached [to senior structure]"  
**Recommended action:** "remove". *Not done.*  
**Comment:** One swing was removed in 2008; put back after public complaints.

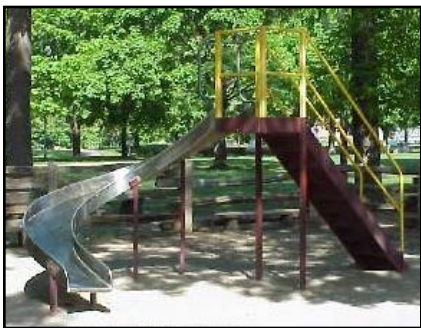
^ 1999 inspection: "Senior spiral slide, no barriers and no exit section".  
**Recommended action:** "remove and replace".  
*Removed. Not replaced.*

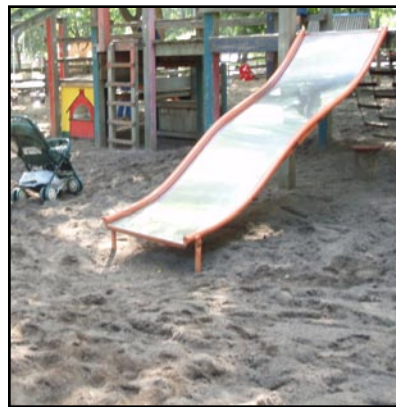
< 1999 inspection: "large slide has no exit platform and low sides".  
**Recommended action:** "remove and replace".  
*Not done.*  
**Comment:** Now the city is installing slides with even lower sides (e.g. Trinity Bellwoods Park). >

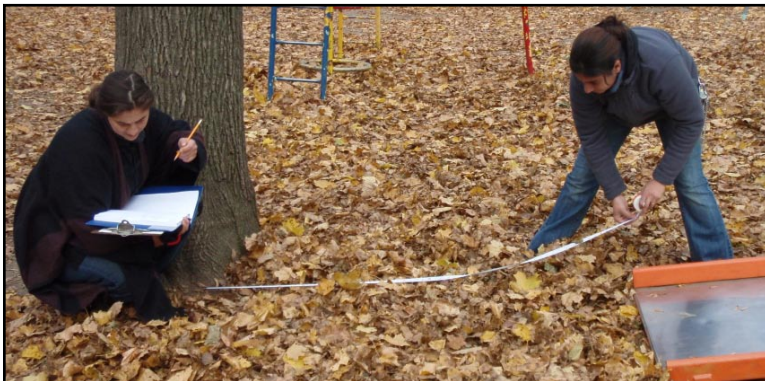
< 1999 inspection: "small slide has tree in exit zone".  
**Recommended action:** "remove". *Not done.*  
**Comment:** The distance from baby-slide to tree is 70 inches - too far for collision. No need to remove the tree.

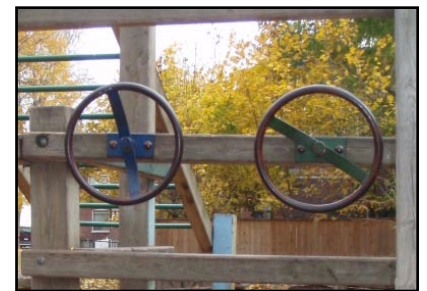
^ 1999 inspection: "open steering wheels"  
**Recommended action:** "replace".  
*Not done.*

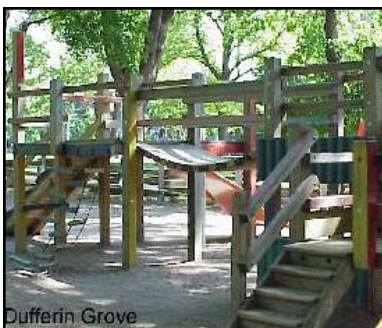
< 1999 inspection: "pinch points on bridge"  
**Recommended action:** "redesign bridge"  
**Comment:** The CSA does not ban jiggly bridges. But Parks workers *replaced it* with > straight boards.  
 1999 inspection: "no barriers" >  
**Recommended action:** "install 80 vertical pickets." *Not done.*  
 1999 inspection: "6x6 posts are play surfaces".  
**Recommended action:** "install 19 caps".  
*Not done*

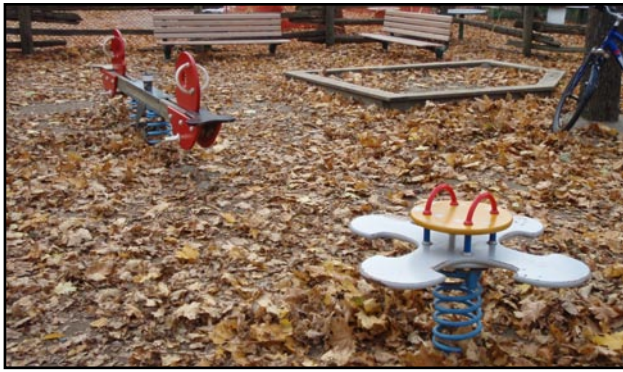
< 1999 inspection: "Daisy spring toy too close to teeter totter"  
 Recommended action: "relocate". *Not done.*  
 Comment: The new 2007 CSA Standard allows this proximity.

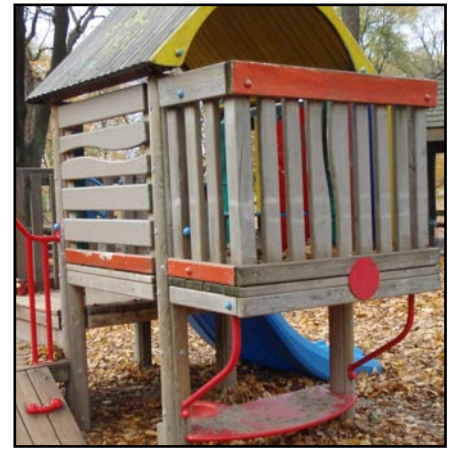
1999 inspection: Playhouse has "climbable horizontal pickets" >  
 Recommended action: "change to vertical."  
*Not done.*

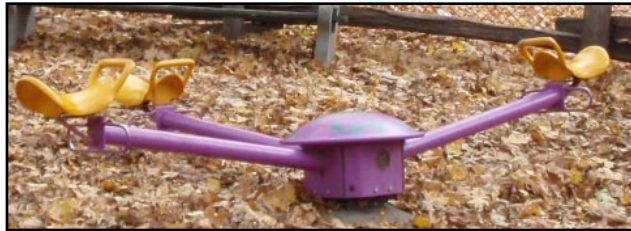
^ Comment: The 4-way teeter totter arm broke off in spring 2008. The City's August 2008 inspection report does not mention teeter totter damage.

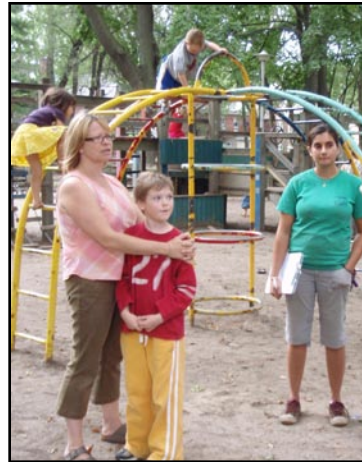
< 1999 inspection: "4-way climber - entrapment at top of arch"  
 Recommended action: remove and replace with two-way climber.  
*Not done.*

Comment: An adult can easily fit her head through the top of the arch without getting stuck. So it is good that this popular climber was not removed. v

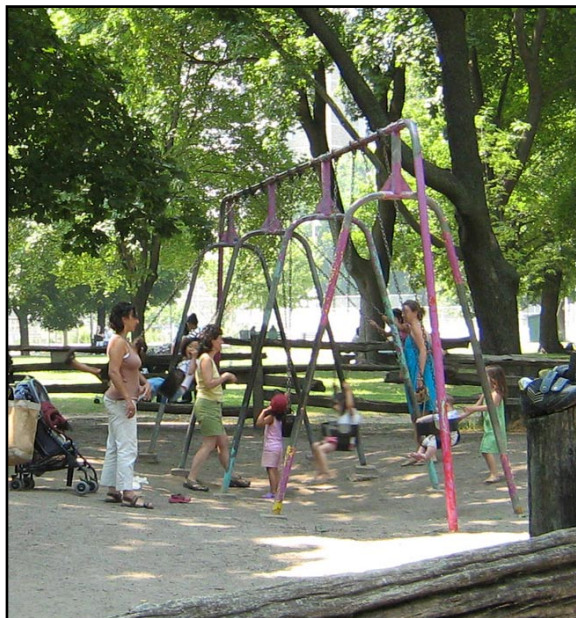
< 1999 inspection: "improper swing spacing".  
 Recommended action: "remove three". *Not done.*  
 Comment: These three swings were removed in 2008 and then put back because of public complaints.
