# CELOS INFORMATION BULLETIN NUMBER 7: INVENTORY: THE CSA PLAYGROUND PROJECT at DUFFERIN GROVE PARK

## A FOLLOW UP OF THE CSA CHANGES MADE AT DUFFERIN GROVE PARK

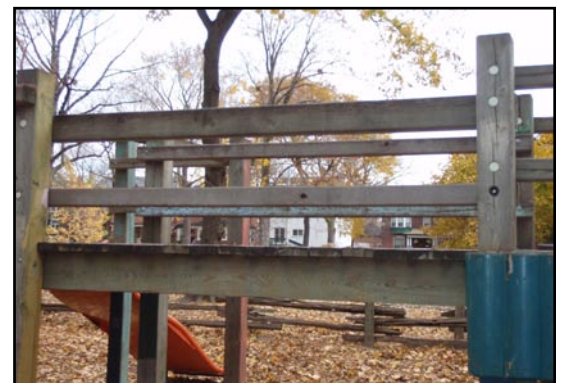
< 1999 inspection: "pinch points on bridge"  
**Recommended action:** "redesign bridge"  
**Comment:** The CSA does not ban jiggly bridges. But Parks workers *replaced it* with > straight boards.  
 1999 inspection: "no barriers" >  
**Recommended action:** "install 80 vertical pickets." *Not done.*  
 1999 inspection: "6x6 posts are play surfaces".  
**Recommended action:** "install 19 caps".  
*Not done*
